# Service Bulletin

Bulletin No.: 21-NA-044

**Subject:** Vehicle Software Update (VeSCoM)

Brand:	Model:	Model Year:		VIN:		Engine:	Transmission:
		from	to	from	to		
Chevrolet	Suburban	2021	2021				
	Tahoe						
GMC	Yukon	2021	2021				
	Yukon XL

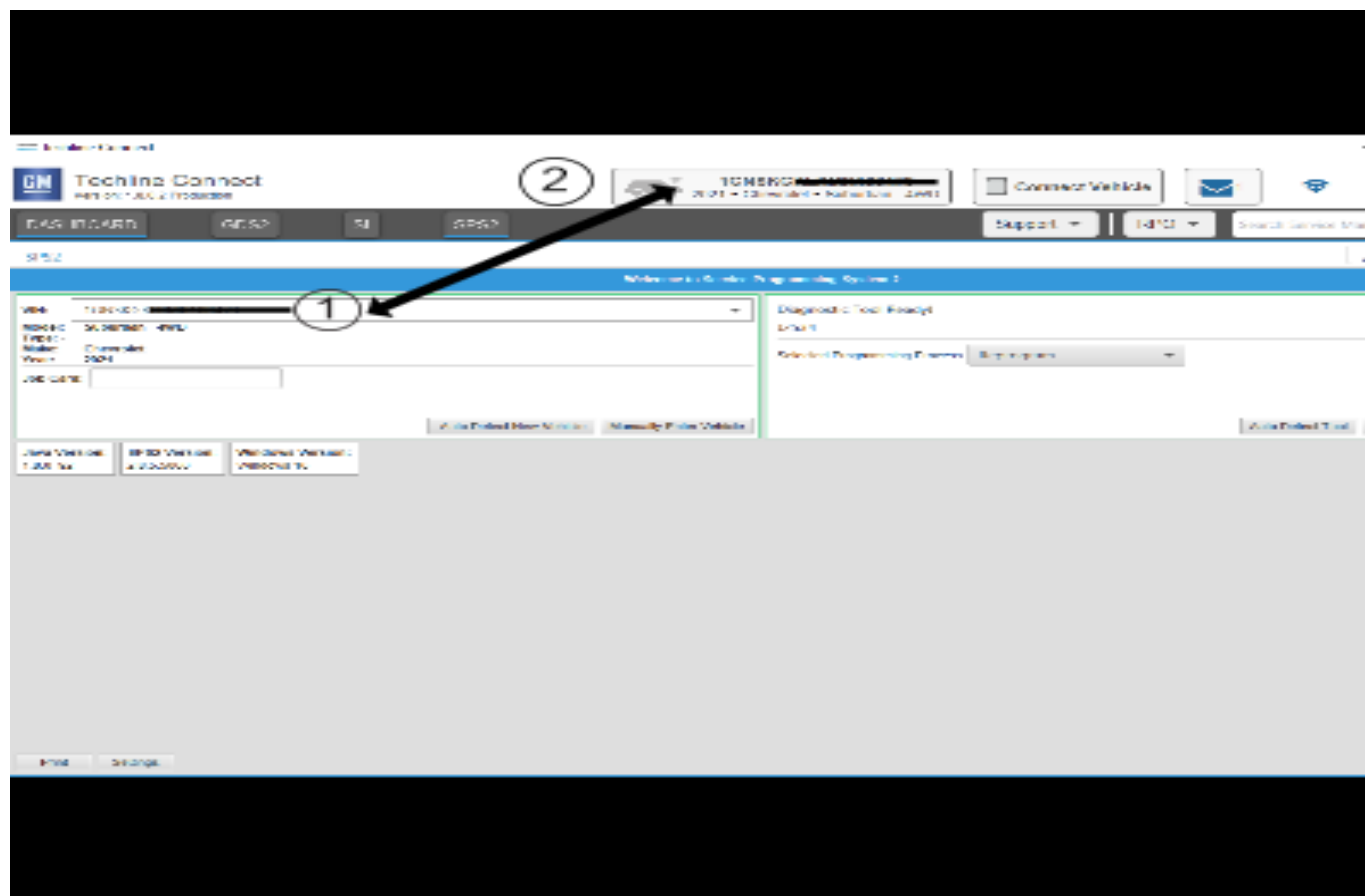
**Caution:** Be sure the VIN selected in the drop down menu (1) is the same as the vehicle connected (2) before beginning programming.

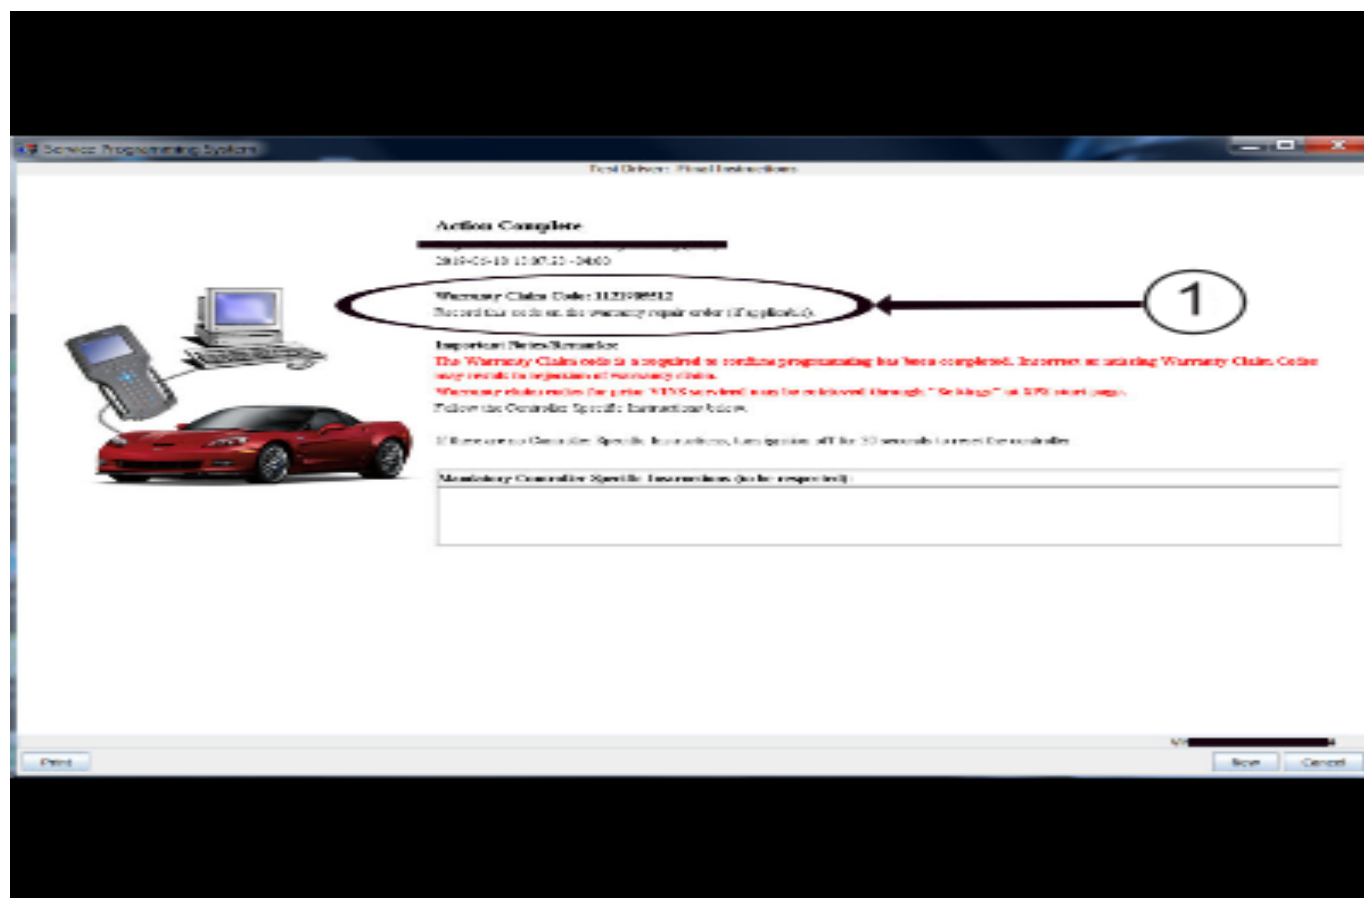
5431209

**Important:** To avoid warranty transaction rejections, you **MUST** record the warranty claim code provided on the SPS Warranty Claim Code (WCC) screen shown above on the job card. Refer to callout 1 above for the location of the WCC on the SPS screen
